United States Department of the Interior
National Park ServiceNational Register of Historic Places
Registration Form

historic name Johnson, Wilbur T. and Rhoda Stephens, House
other names/site number Missouri State DAR Headquarters
Roslyn Heights, 0-32

street & number 821 Main N/A not for publication
city, town Boonville N/A vicinity
state Missouri code MO county Cooper code 053 zip code 65233

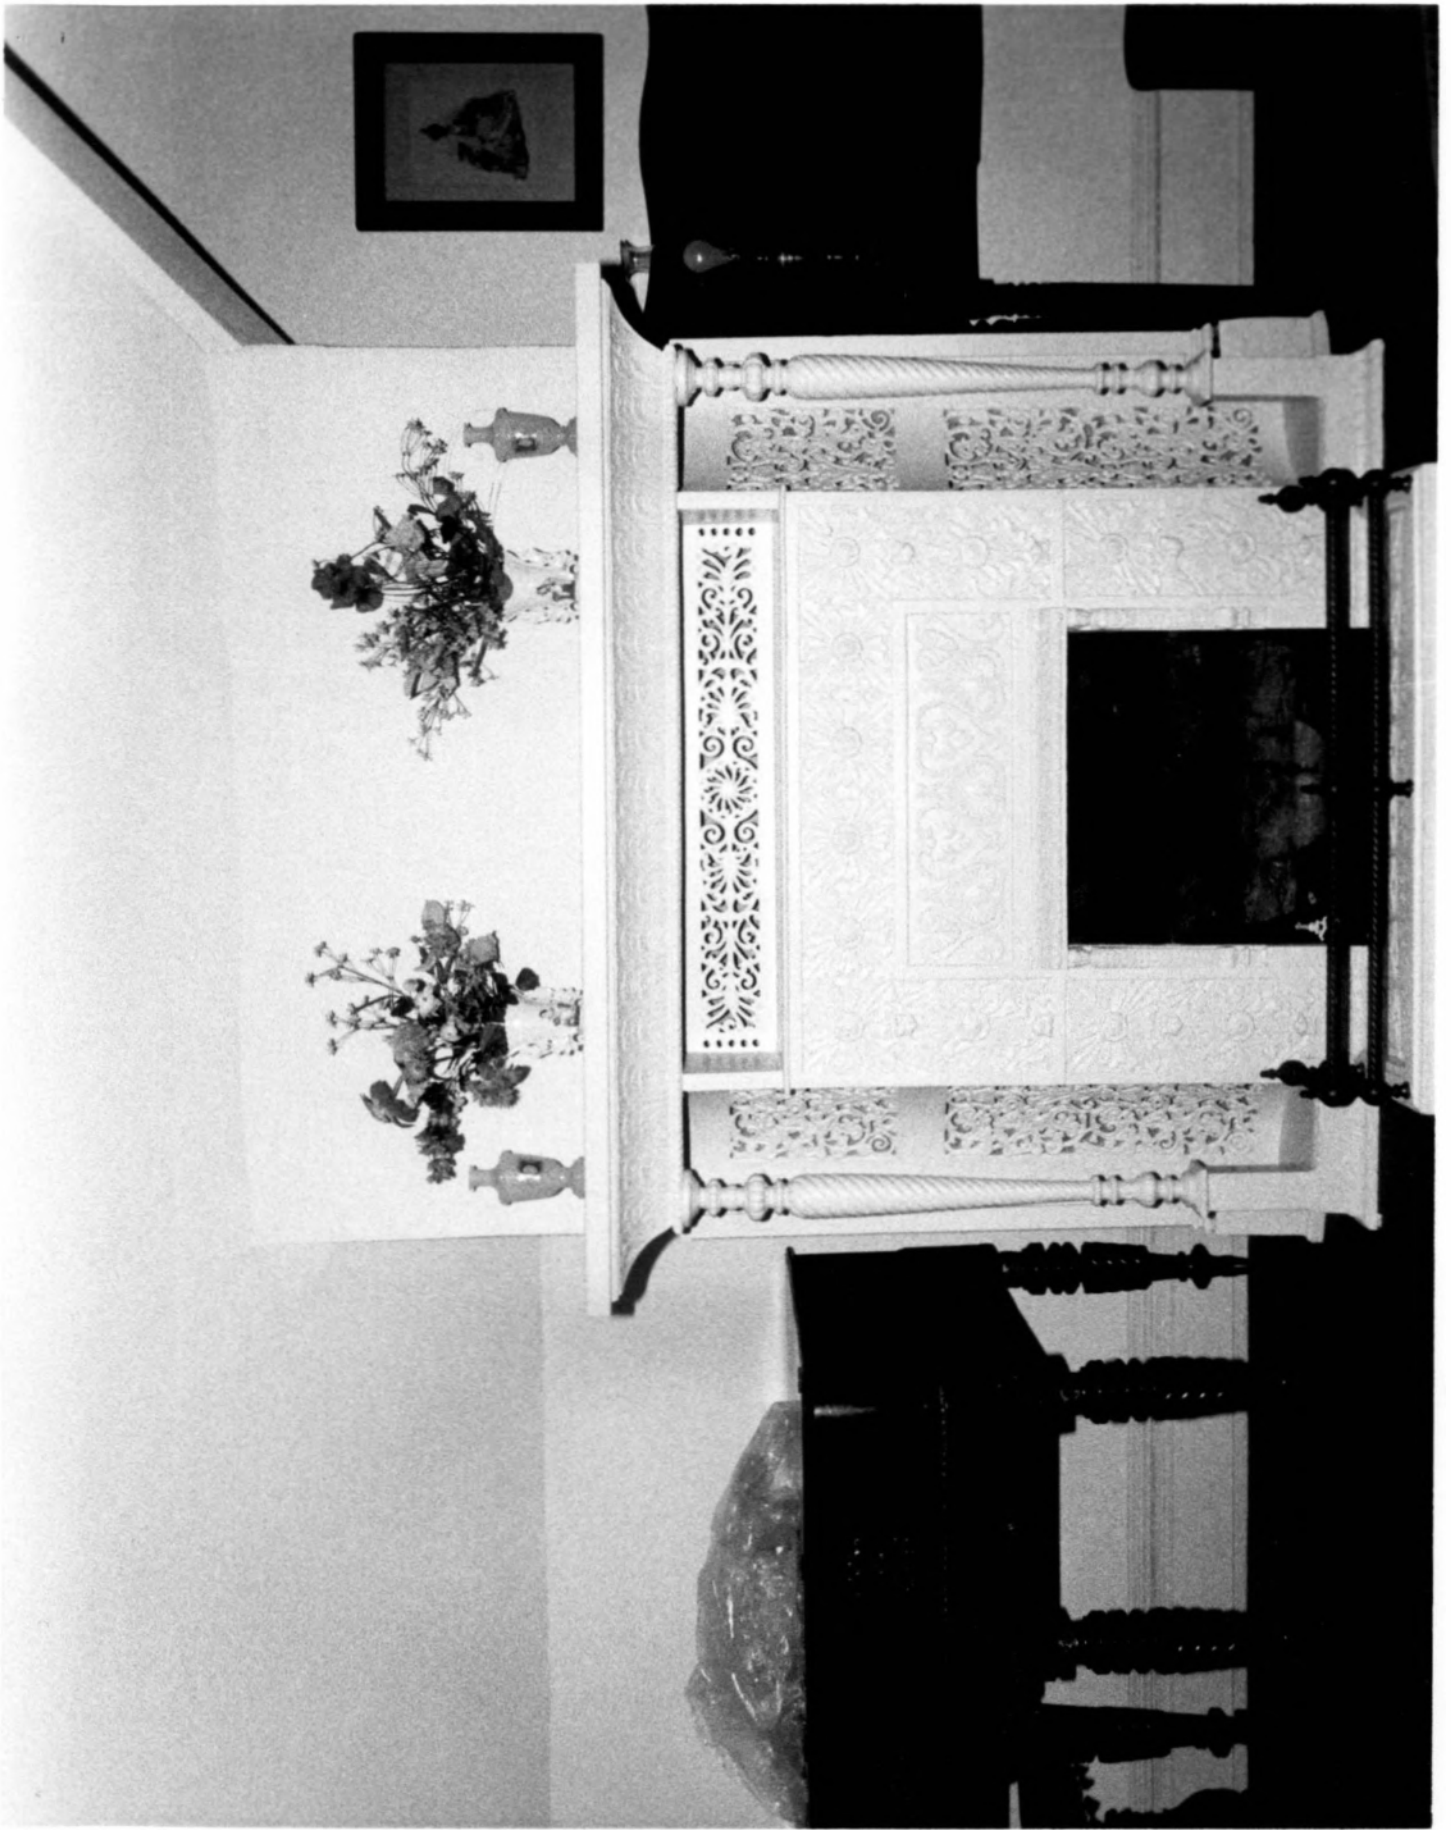
Roslyn Heights
Boonville, Missouri
Maryellen H. McVicker
January 10, 1987
DAR Headquarters at House
Cast Iron Fireplace in Third
Floor Ballroom
Photo #27

The third floor is the ballroom and adjacent cloak room. The ballroom is believed to have spring floors of hardwood, the height of elegance for the late 19th century. The spring movement helped the dancers float over the floor. The final fireplace found in this room is cast iron. The third story tower contains four windows and built-in sitting, while the three dormers provided places for the musicians and tables during parties. The woodwork is plain millwork with bull's-eyes. The adjacent cloak room contains the original cloak closet, complete with original wallpaper and storage bins for top hats. A dumb waiter at one time went from this room down to the kitchen for food and other necessities.

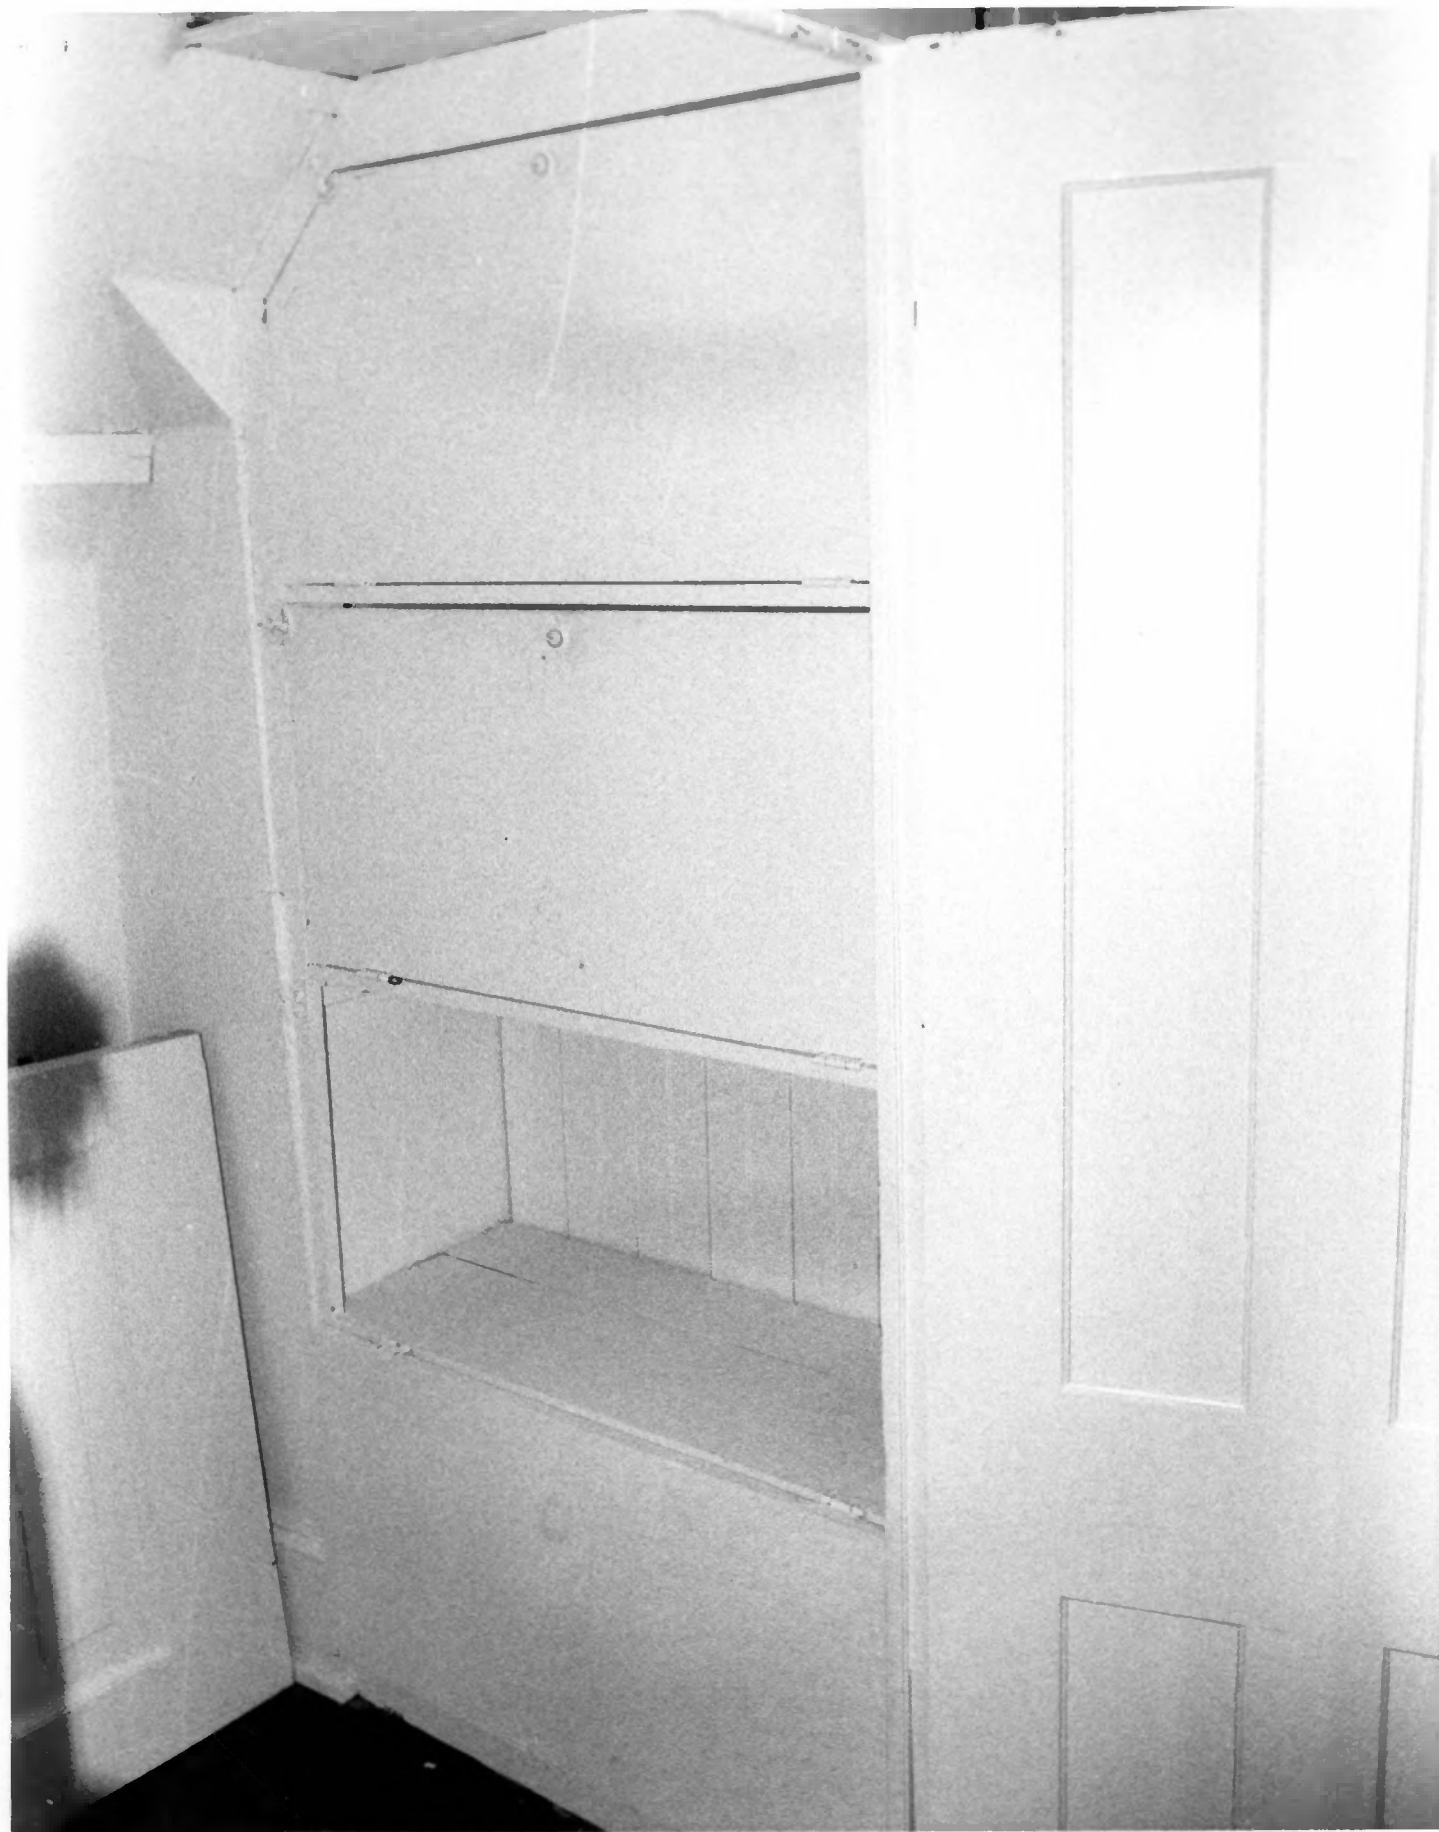
Roslyn Heights
Boonville, Missouri
Maryellen H. McVicker
January 10, 1987
DAR Headquarters at House
Top Hat Storage in Cloak Room

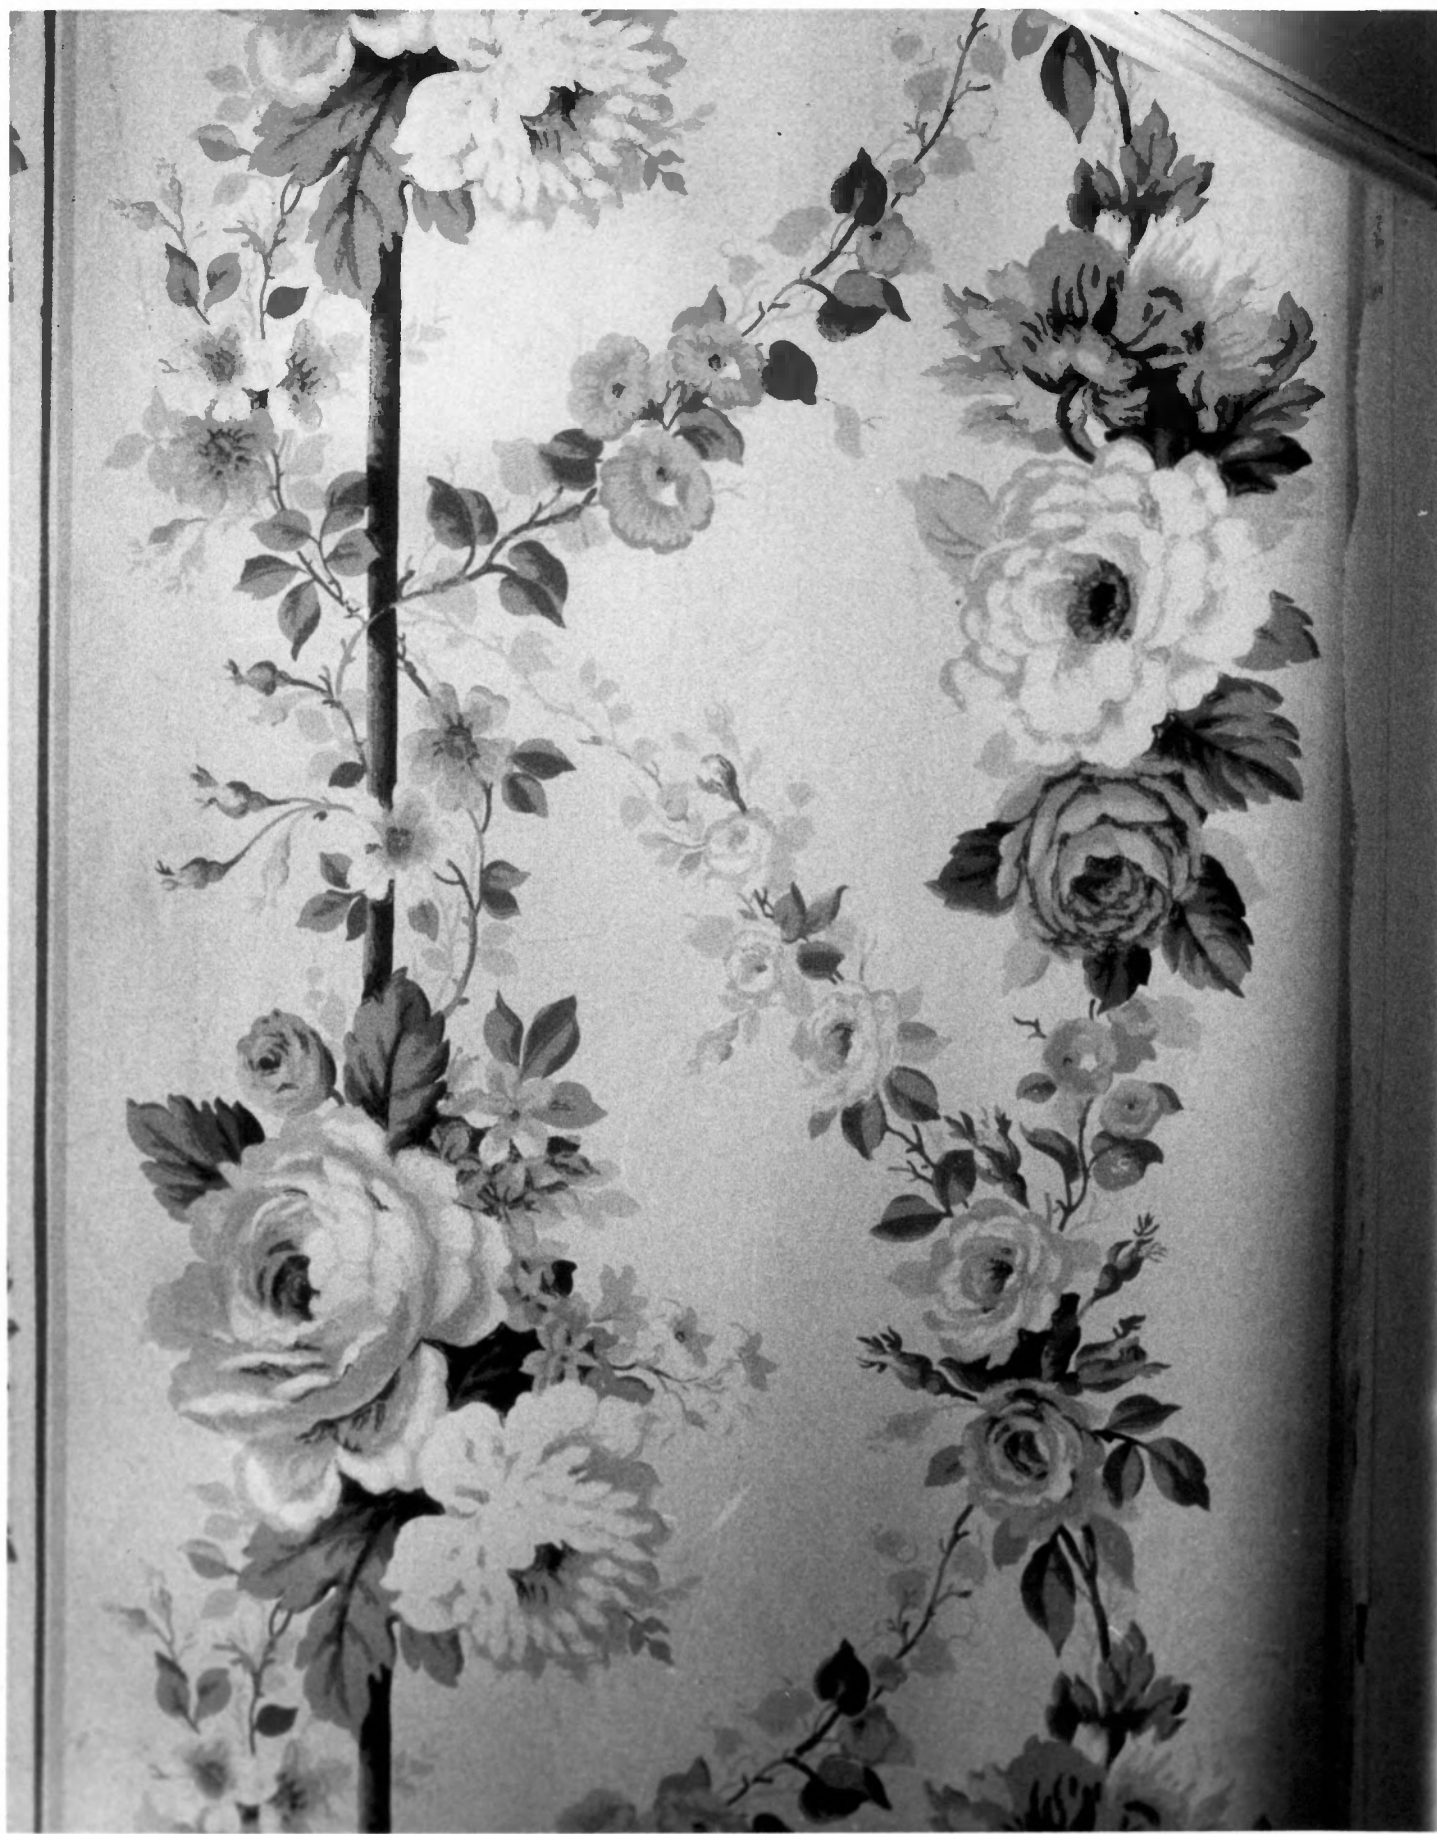
Photo #29

Roslyn Heights
Boonville, Missouri
Maryellen H. McVicker
January 10, 1987
DAR Headquarters at House
Section of original wallpaper
in Cloak Room
